Report No. A221031773710106 Page 1 of 6

Sample Name 样品 1

No.	Test Item			
1	Micro cross section inspection(OM)

Test Item: Micro cross section inspection(OM)

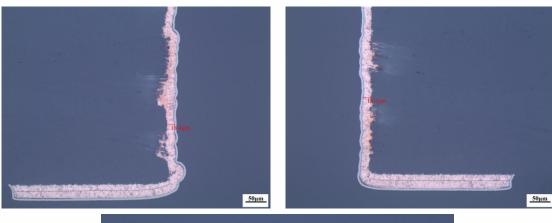
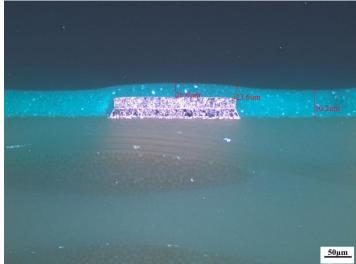
Test Sample	Project	Test Results (μm)						
		1	2	3	4	5	6	Avg.
A2210317737101001	Hole Copper	19.1	19.1	19.1	19.1	18.4	19.1	19.0
	Surface Copper	35.6	35.6	33.7	35.6	34.9	/	35.1
		Base Material	50.2					
	Solder Mask	Copper Surface	26.0					
		Corner	23.6

Test photo(s) of sample A2210317737101001  $(50\sim200X)$
